Reconstructing the damage field of the 1855 earthquake in Switzerland: historical investigations on a well-documented event

Stefan Fritsche, Donat Fäh, Monika Gisler and Domenico Giardini

Swiss Seismological Service, Institute of Geophysics, ETH-Hoenggerberg, HPP L4, 8093 Zurich, Switzerland. E-mail: stefan.fritsche@sed.ethz.ch

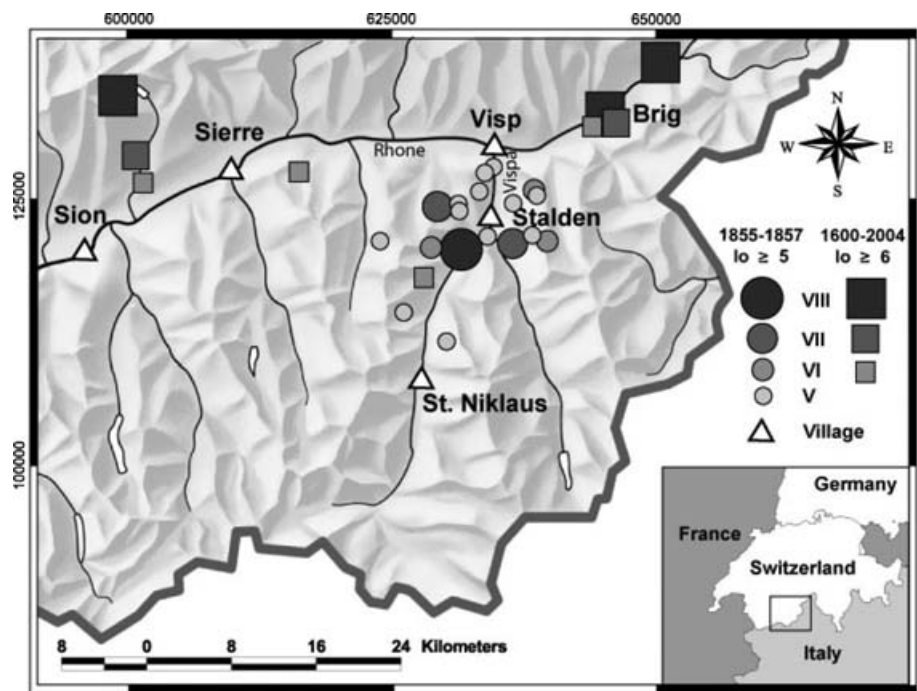
Figure 1. Historical seismicity of the investigated region in the middle Valais.

nation but also in other parts of Europe. The extent of damage was remarkable and is still unsurpassed in the Valais. The large quantity of available contemporary source material such as newspaper and scientific journal articles, travel diaries and entries in chronicles is, therefore, not surprising. Most known of these sources is the dairy of Pastor Moritz Tscheinen (1857). Tscheinen was an eyewitness living in Törbel, a small village in the epicentral area. With high accuracy, Tscheinen listed the series of main and aftershocks by notifying the date, time, strength and manner of the felt events (Table 1 and Fig. 1).

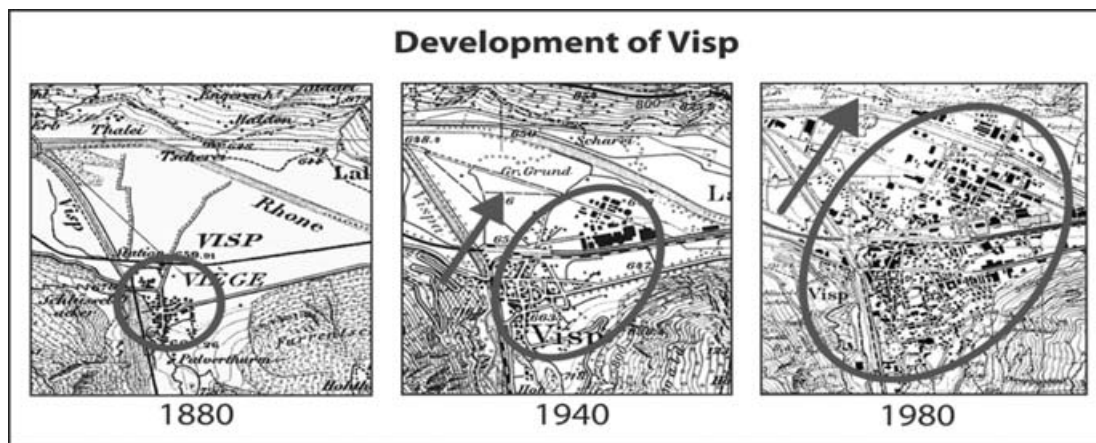
Figure 2. Development of Visp from 1880 to 1980.

attractive places for expanded settlement in the last two centuries: river regulations allowed many villages and cities to grow extensively on these wide plains, as they do in the Rhine Valley or the Valais (Fig. 2). The risk to settlements is therefore increasing. Further research into the relation between damage and possible site effects is definitively merited.

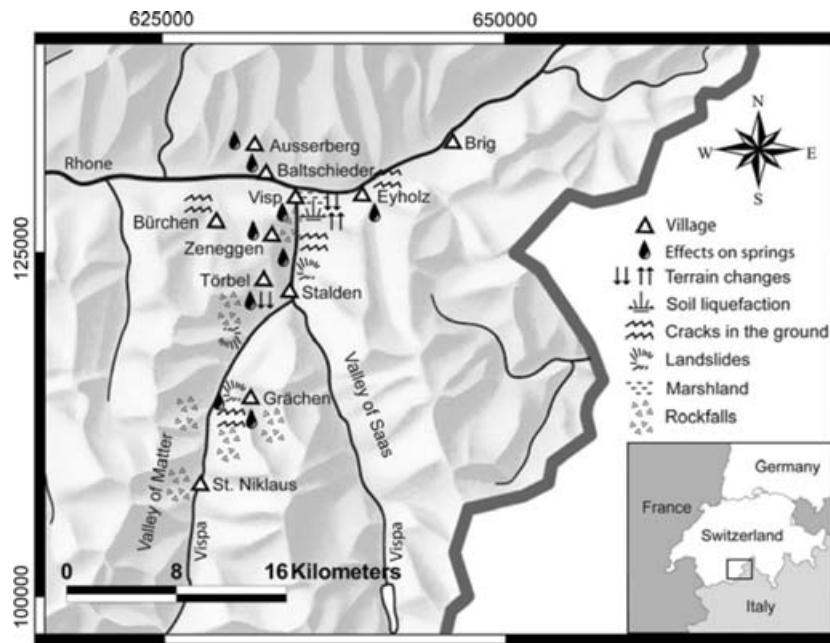
Figure 7. Seismogeological effects in the Valley of Visp.

The next village they visited was St. Niklaus, a small spot of about 30 houses and 70 farm buildings. Like other authors describing the damage to this village, Nöggerath pointed out that the stone buildings suffered heavy destruction: ‘... all of them are either already collapsed or disrupted in a way, that hardly one of them can be repaired.’ (Nöggerath 1855, 24). While Heusser’s report contains no further information on St. Niklaus—with the exception of a meaningful illustration (Fig. 4)—Walter de la Rive’s description is remarkable. Similar to Nöggerath and Heusser, De la Rive pointed out that damage is more apparent than in Visp or Stalden. ‘[...] there is no semi-devastation, the ruins are complete, the houses are not only disrupted but the debris covers the street [...] one of the hotels has quasi disappeared, its façades do not exist anymore [...]’ (De la Rive 1855, 95/96). However, if one believes De la Rive’s report, the disaster could have been much worse. According to him, the meadow above the village was littered with boulders of a rock fall stopped only by the soft soil. This circumstance protected the village from a catastrophe: ‘[...] if the terrain would have been frozen [...] nothing of St. Niklaus would have remained [...]’ (De la Rive 1855, 95/96) (Fig. 7).

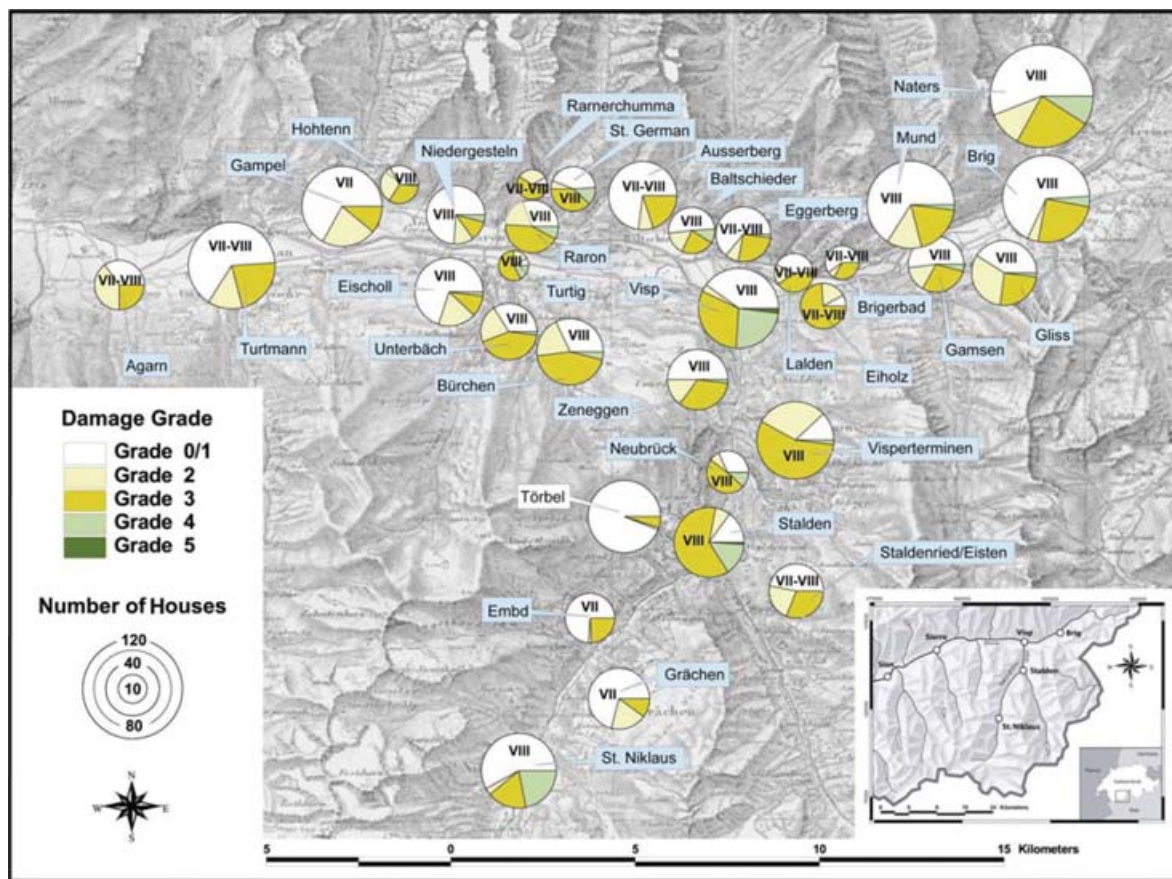
Figure 8. Damage grades and intensities assigned on the basis of the damage lists. For locations with intensity degrees in the form of VII–VIII, it was not possible to decide which value is appropriate. They contain elements of intensity degrees VII and VIII. (Grünthal 1998, p. 57).

Fig. 8 summarizes the results of the assessed damage field on the background of a reproduced map (1:100 000) first published in 1854 (Bundesamt für Landestopographie 1988). The investigated regions are plotted as pie charts. Their size is proportional to the total number of existing houses at that time. The coloured segments indicate the different damage grades. As mentioned, damage of levels 1 and some of 2 were not assessed and are, therefore, included in the white coloured segment representing the undamaged buildings. The assigned intensity degrees are represented by roman numerals. Before going into detail, we will compare this figure with the descriptions and comments in paragraph 4 (an overall description of the damage field pp. 11–17). Two differences are obvious. While the highest intensities in Fig. 8 are of grade VIII (heavily damaging), an assignment of intensities on the basis of the quotations in paragraph 4 would instead produce intensities of up to grade IX (destructive).

On the other hand, the geographic range containing assured information about losses in this paragraph is much smaller than shown in Fig. 8. These are typical phenomena in the context of historical data: historical documents often address a broader public focus in considering the most remarkable or newsworthy effects of an earthquake (Grünthal 1998, 52), particularly if the society believes the

After a closer look at Fig. 8, the following deserves attention. According to EMS 98 damage occurs in the range of intensity VI and higher (Grünthal 1998, 18–20). However, our damage field shows no intensities of degree VI, not even on its borders. This is due to the fact that intensity VI is defined by damage of grades 1 and 2, which did not (or only partly) match the criteria to obtain compensation payments. Thus, we have to assume that outside the figure border localities showing intensities of degree VI were present in 1855. Fig. 9 is based on several earthquake catalogues and confirms this assumption, showing the investigated region as part of the entire macroseismic field.
